Solar Energy Implementation Case Study

Pork Chop Hill Farm LLC

By Jackie Thelen, Aryn Thomas, and Al Go
Michigan Farm Energy Program

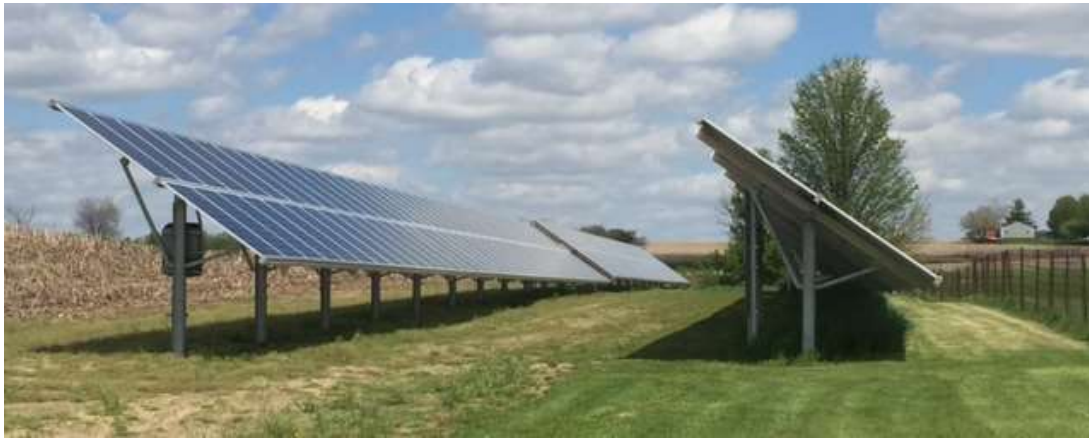
Figure 1 - The 75 kW solar energy system, positioned between a field and sheep pen.

The second solar energy project implemented at Pork Chop Hill Farms was a fixed, ground-mounted solar array with a vibrated I-beam structure including 2 sub-arrays of 150 250 W modules each, for a total of 75 kW. The system was installed by Harvest Energy Solutions, implementing SolarWorld panels and Fronius inverters. The solar field was positioned between their field and sheep pen, with an overall footprint of 9,065 square feet (37 by 245 feet). The system was designed to offset 90% of annual energy usage for the farm's machine shop, feed mill, and grain dryer system. A full specification sheet of the solar energy system as well as an aerial view of the system and surrounding property can be viewed in Attachment 1.

Harvest Energy Solutions managed the material requirements, coordination with the electrical contractor and utility, and the final installation of the system. Harvest Energy provided ideas for locations and orientations, but Tom and Margaret decided on the final location of the new arrays to best suit the needs of their operation. Starting on September 11, 2015 and lasting until September 22, 2015, the installation of the solar energy system went smoothly. The farm owners commented on the tidiness of the contractors, who cleaned up even small pieces of debris after the installation. Since this unit was larger than the first system, the installation process lasted considerably longer than the first 19.76 kW system—11 days compared to 4 days. The system was connected to the energy grid by a separate electrician and commissioned by the utility. For the first month, however, the farm owners noticed that they were not receiving any energy credits for net electricity produced. Consumers Energy came out to examine the system and found that it had been wired to the grid incorrectly. After a few adjustments, the system was running perfectly, with no maintenance or electrical issues to date. The solar panels were positioned between a field and the sheep pen, out of the way but still close to the operations it was designed to power, so the installation did not inhibit the farm's typical processes. A picture of the completed system can be seen in Figure 1.

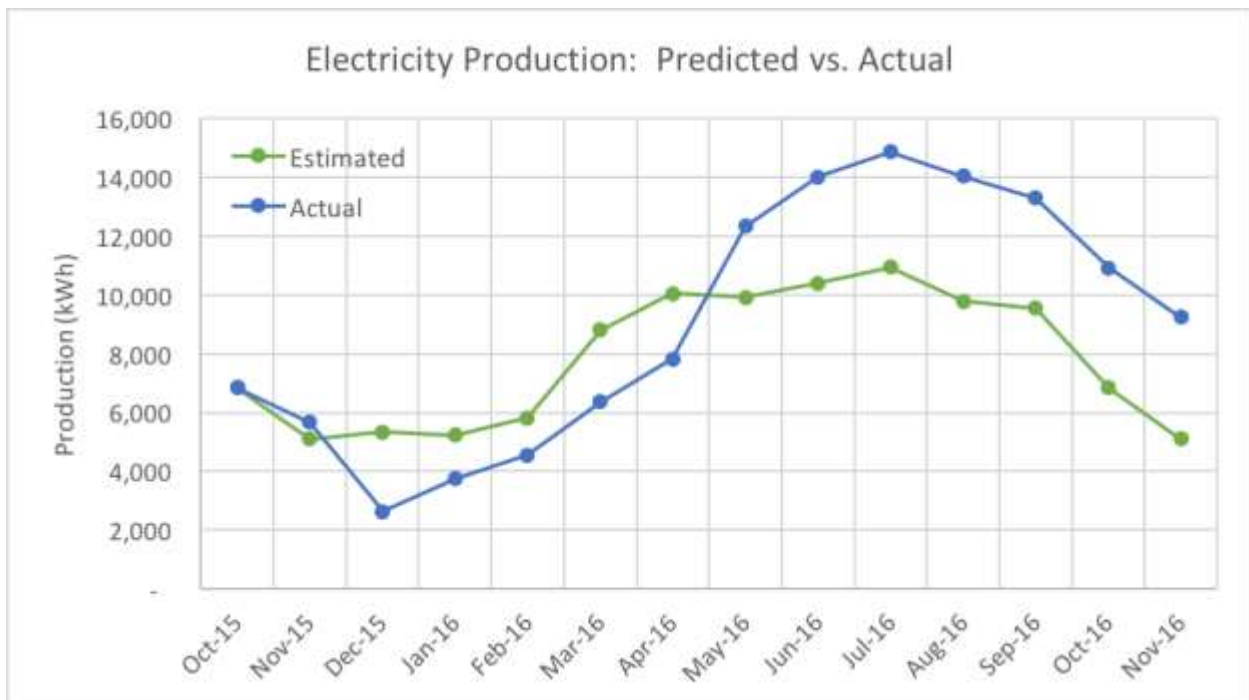
Figure 2 - Electricity produced by Pork Chop Hill’s solar energy system since implementation compared to predicted values provided by Harvest Energy Solutions

electrical production of the system. The utility sends the owners a customized statement for the solar energy system on a monthly basis. Monthly data of actual and predicted electricity production is shown in Figure 2, and raw data is included in Attachment 2. Predicted values are based on Harvest Energy’s solar electricity production averages of previous years. The system produced less over the winter months than predicted, though this is not presumed to have a major effect on the overall annual performance of the system since the majority of energy is produced in the summer months. This deviation may have resulted from the above-normal cloud cover in Michigan due to the strong effects of El Niño, experienced between December 2015 and May 2016. See Attachment 3 for additional data showing the impacts of El Niño on cloud cover.

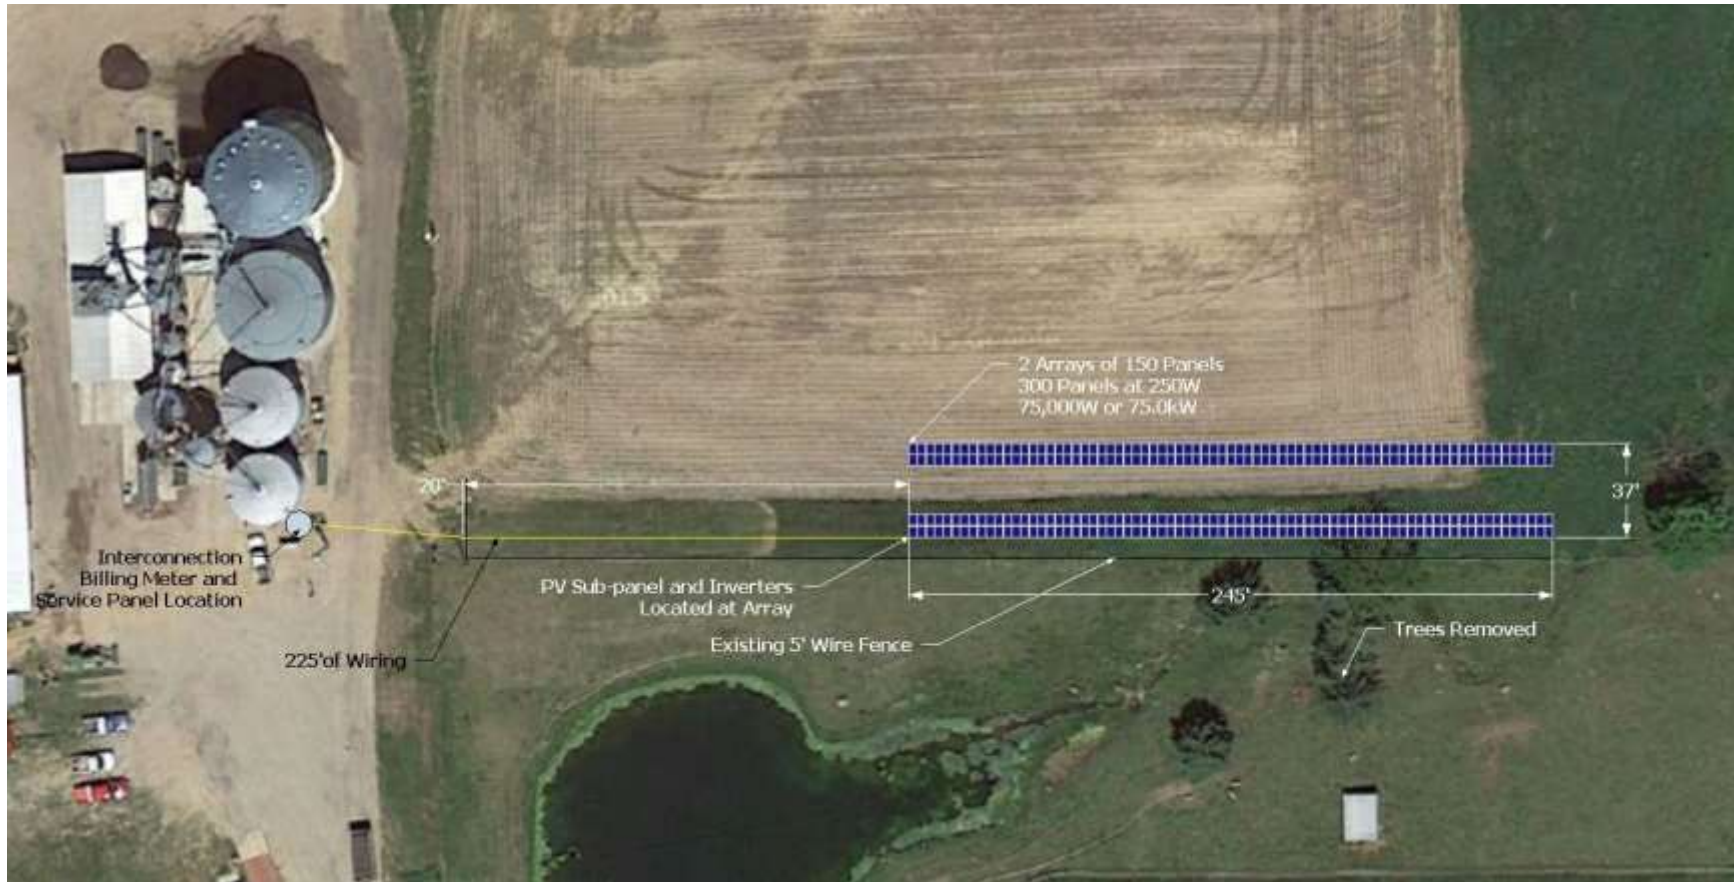
Attachment 1

Below is an aerial view of property with the original schematic of the solar arrays and electrical connections. This shows Pork Chop Hill's second solar energy project located between the field and sheep pen.
