# Assessing the Accuracy of the Michigan EnviroImpact Tool

## **2020 FINAL REPORT**

Jason Piwarski

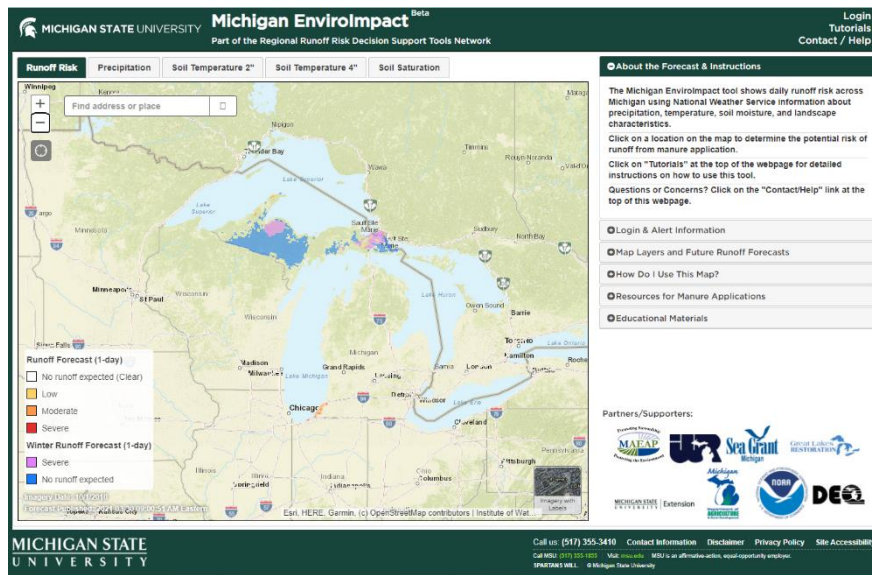
Figure 1 - Screenshot of the Michigan EnviroImpact website interface.

Michigan EnviroImpact is a tool that is based upon a runoff risk model created, provided, and maintained by the National Weather Service (NWS), which was validated across four states in the Midwest, but was only validated against a single edge-of-field site in Michigan. Because of only having a

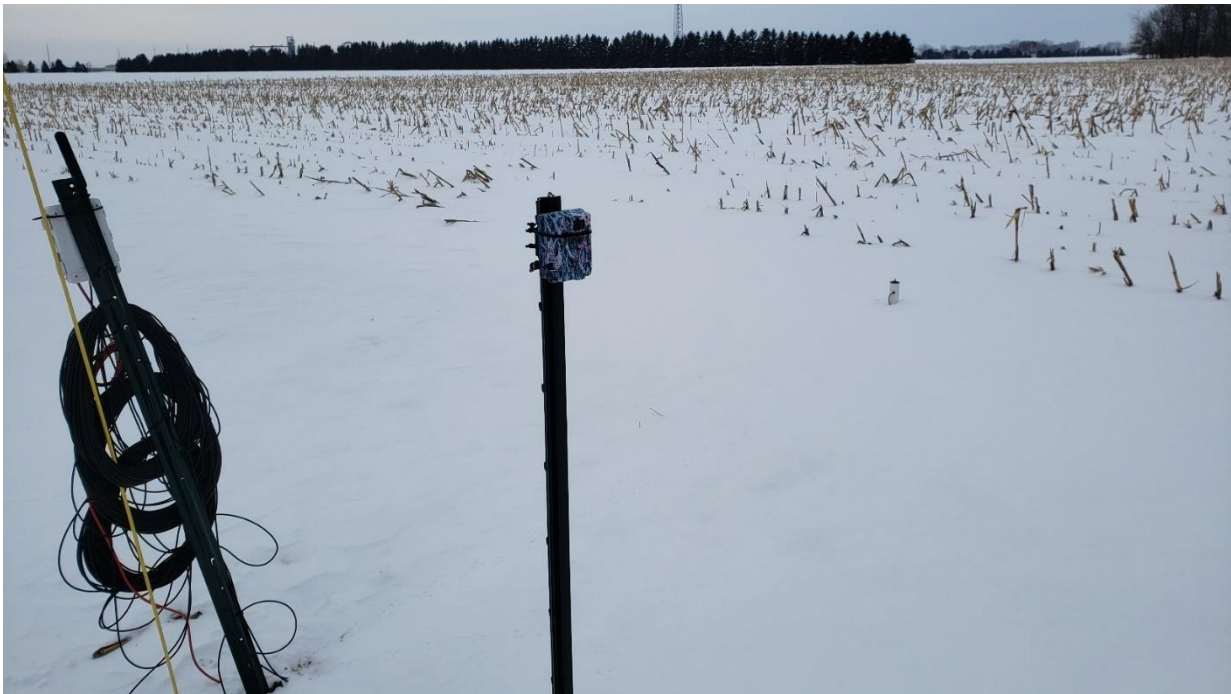
*Figure 2 - Browning Trail Camera that was used for observing surface runoff. This camera is located at the BL site.*

For this project, ten cameras were setup at three locations to take photos of runoff events. The camera that was selected for observing runoff is the Browning Trail Camera Strike Force Pro XD Dual Lens 24MP Game Camera. This camera can take 24MP photos, which adequately allows for the observation of runoff during daytime, even at some distance from the camera. The time-lapse photography setting on the device prevents taking time-lapse photos at night, so therefore observing runoff events at night is not available. At the start of the project, the cameras were setup to take photos on an hourly basis, with the goal of capturing surface runoff as it occurs in fields. After a short period, this frequency was increased to every 30 minutes to better capture any events. Photos were then compared to the 24-hour forecast that has been provided for that day. Cameras were located on site starting on March 12, 2020 at three separate farms that we currently have permission to setup equipment. The farms were visited on a minimum of a weekly basis by personnel to conduct on-going research and download photos from the cameras.

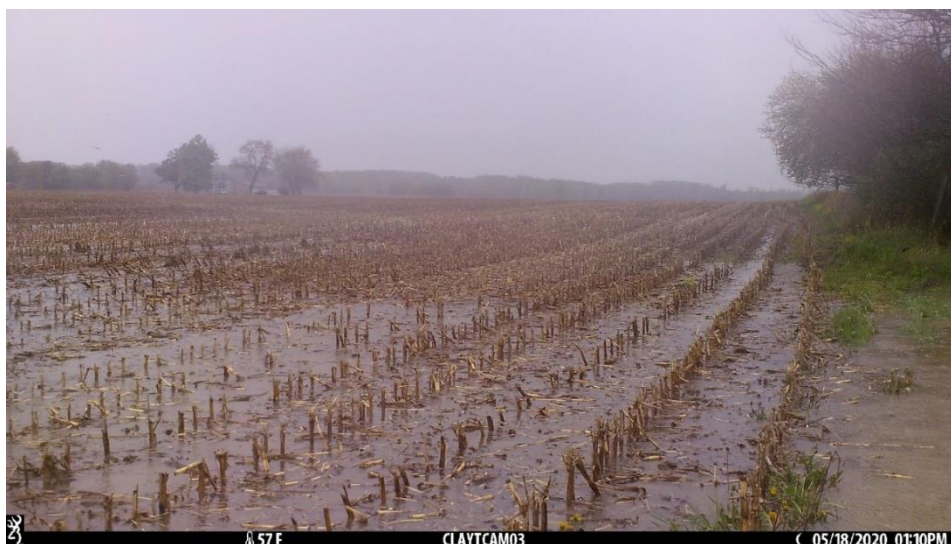
*Figure 6 - Above you can see the CL site during a large runoff event on May 18, 2020. While visiting the site to collect the photos, the deposition of crop residue was seen throughout the area to the right of the photo. As a side note, this event was successfully predicted by the runoff risk model.*
